**CARDIVNSWC-TR-61-94/15** July 1995

Survivability, Structures, and Materials Directorate Technical Report

# **Evaluation of Galvanic and Stray Current Corrosion** in 70/30 Copper-Nickel/Alloy 625 Piping Systems

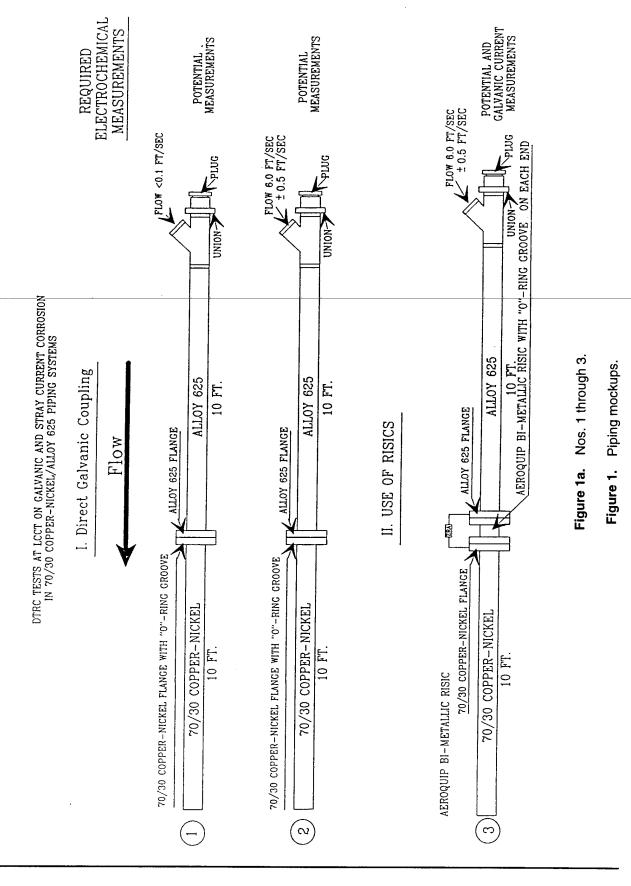
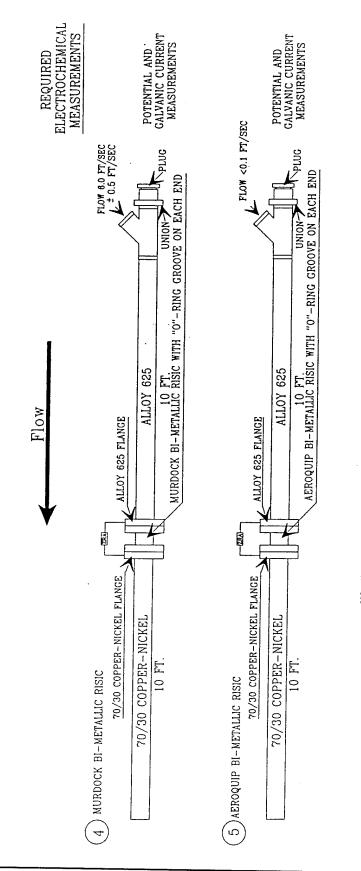
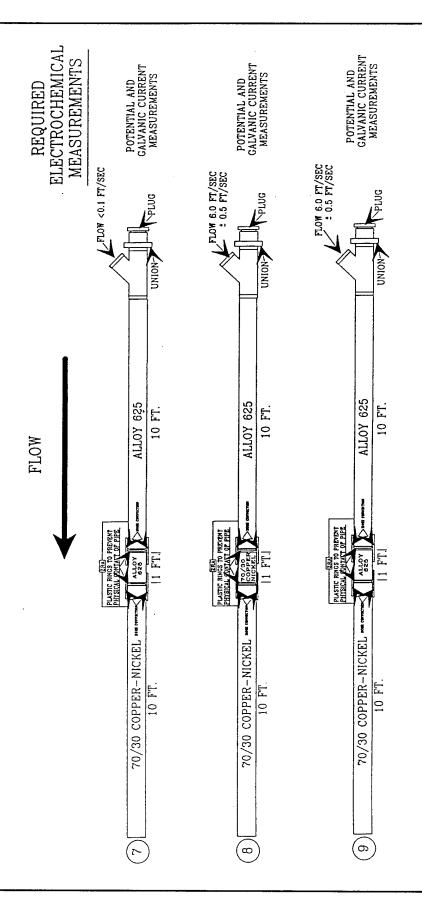
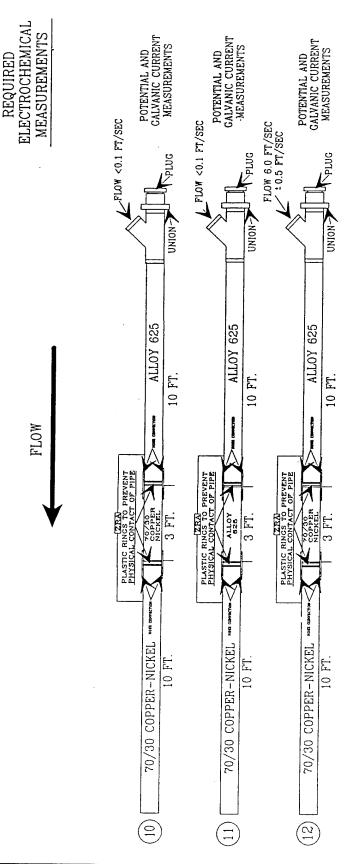
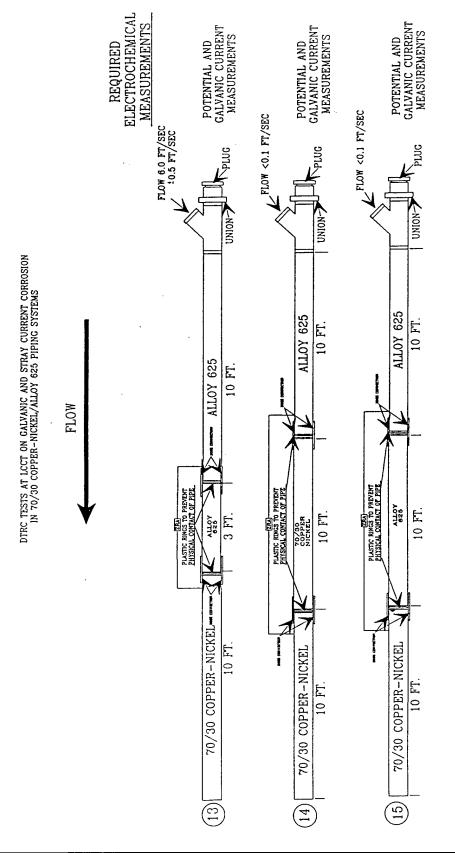
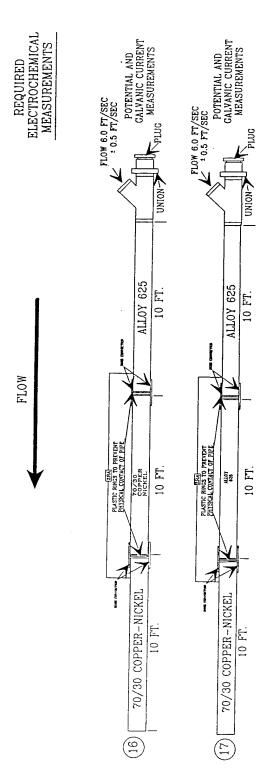
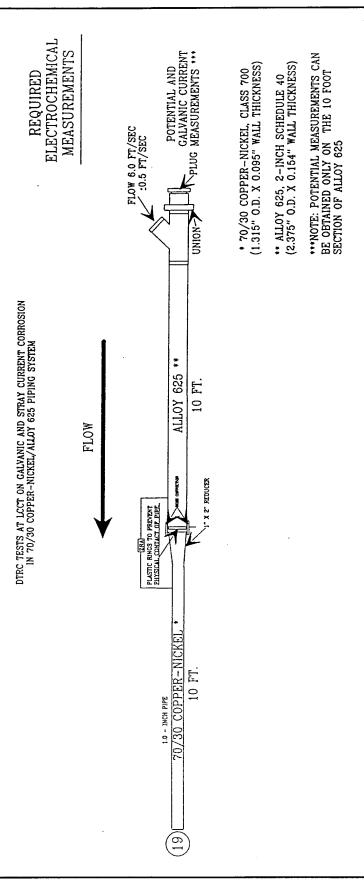
Figure 1. Piping mockups.

The mockups were operated for 1 yr, with shutdown and disassembly after 6 mo to examine the progress of the corrosion. Each mockup was shut down individually and disassembled for measurement with a minimum of disturbance to the corrosion products that had already formed or to the operation of the other mockups. The exact flow maintained in each mockup is shown in Figure 1.

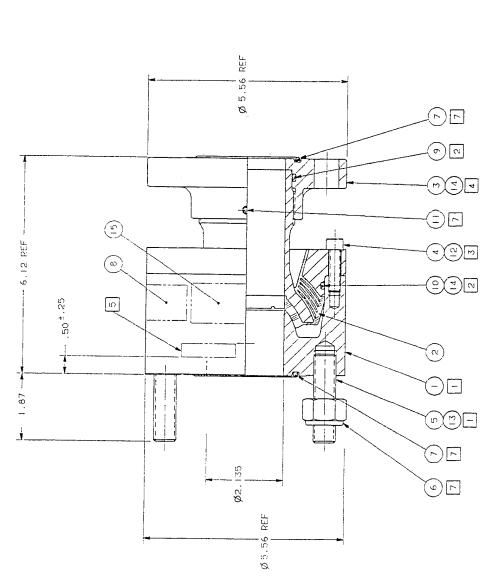
Figure 2. Murdock type 1 RISIC-2A.

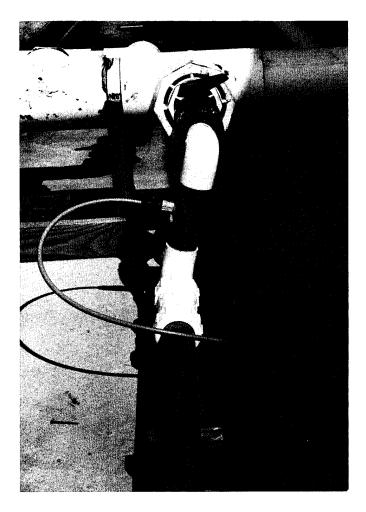
Figure 3. Main seawater supply line to mockups.

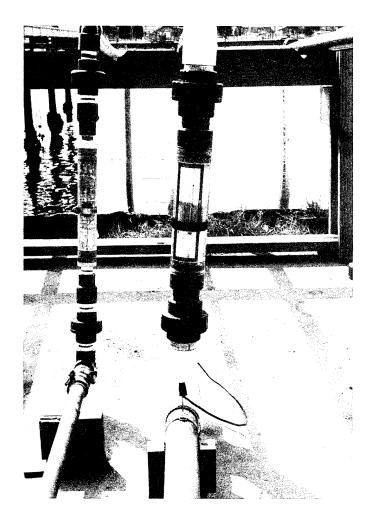
Figure 4. Rotameter in discharge end of mockup.

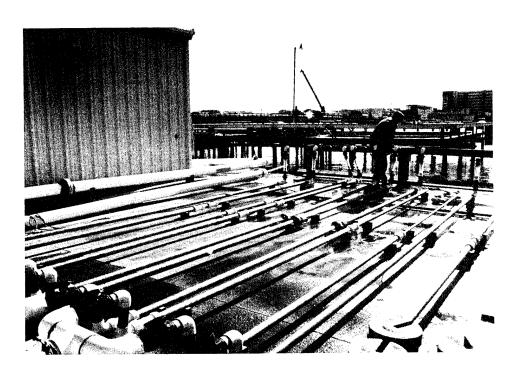
Figure 5. Overall view of mockups under construction.

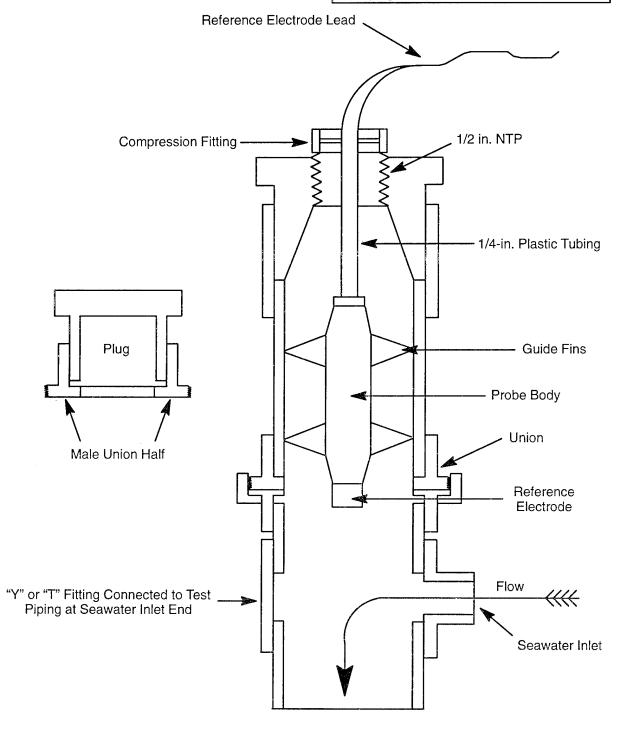
Figure 6. Potential measuring probe.

Corrosion potential vs. distance measurements were made several times during the 1-yr exposure period on all mockups. These measurements were made in 1-ft (30-cm) increments from the seawater inlet side to the discharge end of the pipes. Mockups 14 through 17 exceeded 30 ft (9 m) in length. Therefore, an Ag-AgCl reference electrode was mounted in a very long probe. Figure 6 is a schematic drawing of the potential measuring probe. In the design of the probe, the following major objectives were pursued:

- 1. To allow potential measurements to be made in each mockup while seawater was flowing under normal test conditions;
- 2. To have no interruptions in the other mockups while measurements were being made in one;
- 3. To maintain the reference electrode in the center of each pipe during the course of the measurement;
- 4. To seal the electrical lead wire against contact with the seawater.

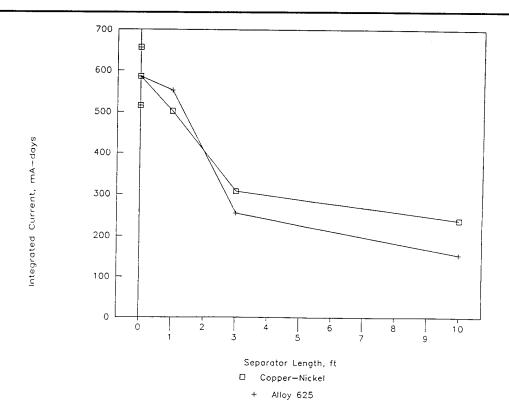
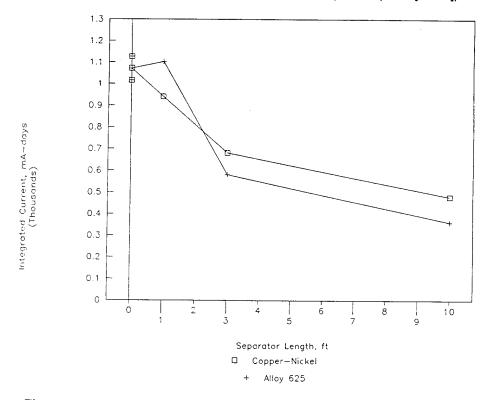
Figure 7. Effect of separator length over first 6 mo exposure (6 ft/s [2 m/s]).

Figure 8. Effect of separator length over 1 yr exposure (6 ft/s [2 m/s]).

The galvanic currents that were measured between the alloy 625 and the coppernickel coupled pipes (shown in Table 2) started high and decayed with time, but were too erratic to easily determine a steady-state current. Instead, each current time curve was integrated to determine the total charge passed during the exposure. The result should have been closely related to the total amount of metal loss of the coupled copper-nickel section. These integrated current values, determined for each piping mockup after 6 mo and, again, after the 1-yr exposure, are plotted in Figures 7 to 12.

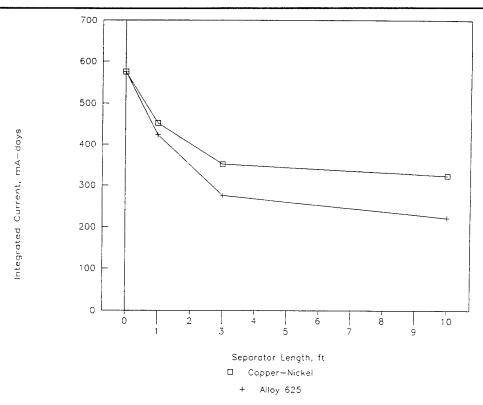
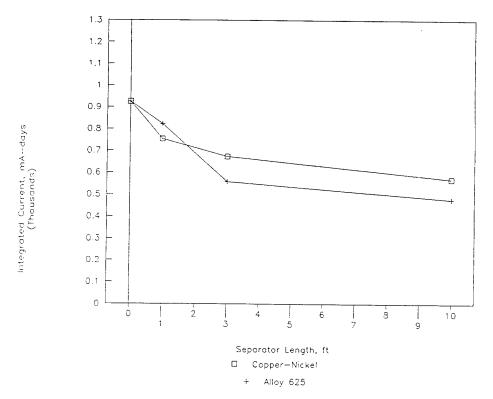
**Figure 9.** Effect of separator length over first 6 mo exposure (less than 1 ft/s [0.3 m/s]).

Figure 10. Effect of separator length over 1 yr exposure (less than 1 ft/s [0.3 m/s]).

Figures 9 and 10 show similar data for the mockups with less than 1 ft/s (0.3 m/s) flow. Overall currents for mockups with separators under low flow are higher than under flowing conditions by a factor of up to two. It appears that separators are more effective at controlling galvanic corrosion under low flow conditions than at 6 ft/s (2 m/s). Most of the metal loss suppression occurred with 3-ft (1-m) separators. The use of longer separators had little additional effect. Significantly greater suppression of metal loss occurred using the alloy 625 separators, as previously observed for higher flow conditions.

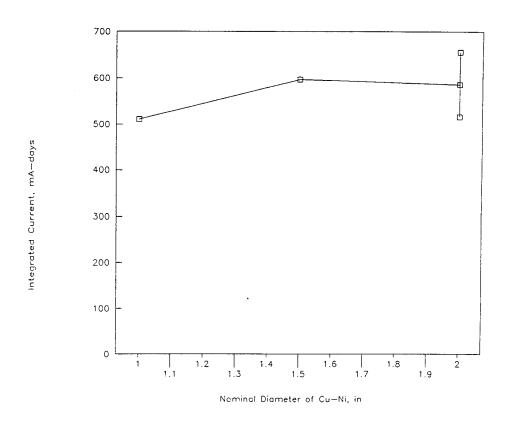
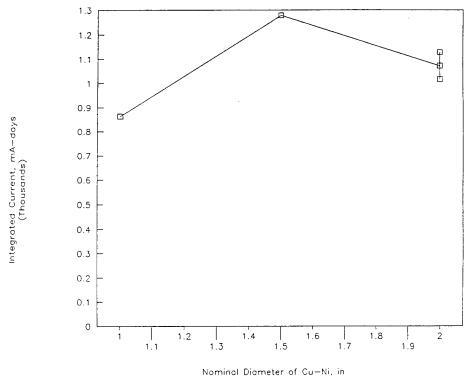
Figure 11. Effect of diameter over first 6 mo exposure (6 ft/s [2 m/s]).

Figure 12. Effect of diameter over 1 yr exposure (6 ft/s [2 m/s]).

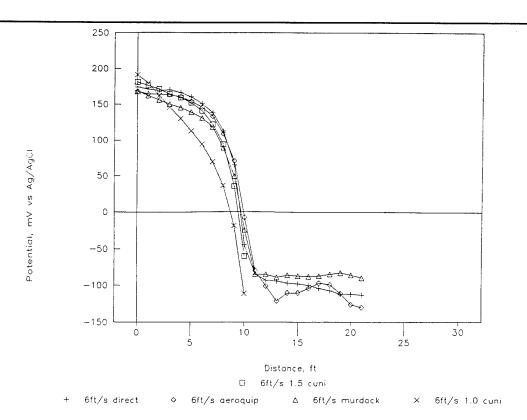
**Figure 13.** Potential profiles of all mockups without separators after 6 mo exposure (6 ft/s [ 2 m/s]).

Figures 16, 17, and 18 are the same plots as Figures 13, 14, and 15, except they indicate an exposure time of 1 yr. Figure 16 is a plot of potential profiles on the inside of the mockups without separators after about 1 yr of exposure. There is more data scatter than the 6-mo data in Figure 13. The potential of the copper-nickel was relatively unaffected by distance from the interface beyond the first 2 ft (0.7 m), indicating a spreading of the corrosion effects. Potential changes in the copper-nickel because of changes in pipe diameter still could not be measured. The potential and profiles inside the alloy 625 were highly variable, making it impossible to assess the effects of changes in copper-nickel

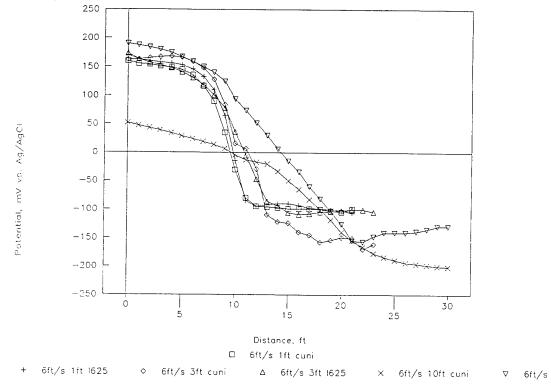
**Figure 14.** Potential profiles of all mockups with separators after 6 mo exposure (6 ft/s [2 m/s]).

Figure 15 shows potential readings for all mockups with and without separators tested at less than a 1-ft/s (0.3-m/s) flow. As in Figure 14, the first 10 ft (3 m) are within the alloy 625; the last 10 ft (3 m) are within the copper-nickel. A length from zero to 10 ft (3 m) between these is within the isolated separator piece. Also, as stated previously, linearity of potential is not possible to observe for the 1-ft (0.3-m) separators. The 3- and 10-ft (1- and 3-m) copper-nickel separators show nonlinearity, indicating a possibility of stray current corrosion, and the 3-ft (1-m) alloy 625 separator shows linear potentials. Unlike Figure 14, the 10-ft (3-m) alloy 625 separator shows nonlinear potentials. In fact, this is the only instance where corrosion was actually observed on the alloy 625 after 6 mo exposure. Corrosion was due to stray current accelerated crevice corrosion on the exterior of the pipe under the compression fitting gasket.

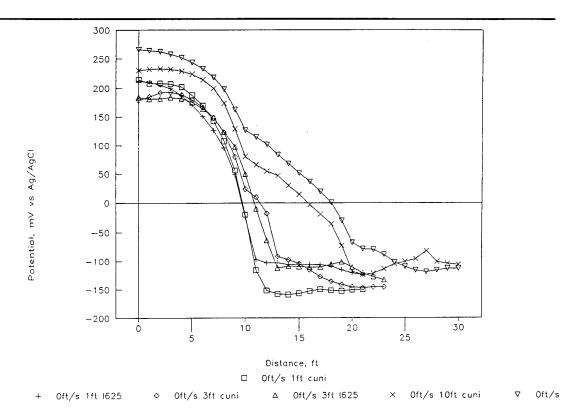
**Figure 15.** Potential profiles of all mockups with separators after 6 mo exposure (less than 1 ft/s [0.3 m/s]).

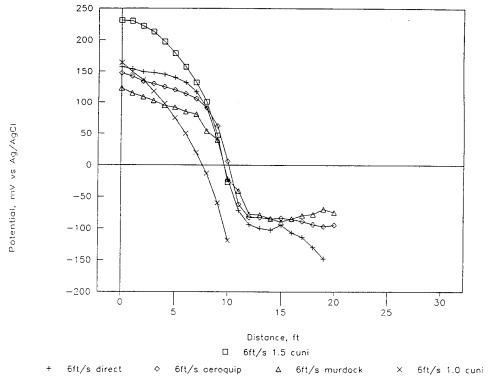
**Figure 16.** Potential profiles of all mockups without separators after 1 yr exposure (6 ft/s [2 m/s]).

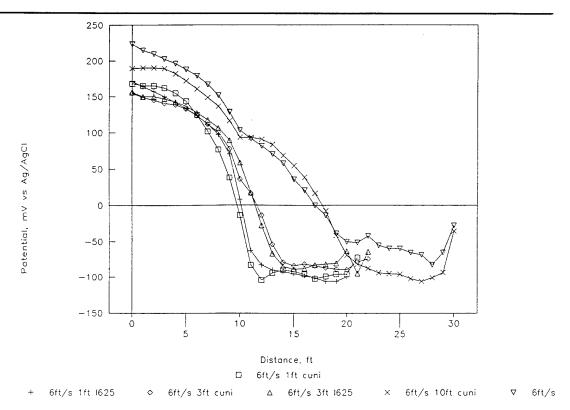
**Figure 17.** Potential profiles of all mockups with separators after 1 yr exposure ( 6 ft/s [2 m/s]).

Figure 17 shows potential readings for all mockups with and without separators tested at a 6-ft/s (2-m/s) flow with nominal 2-in. copper-nickel pipe after about an exposure of 1 yr. Linearity of potential within the separator areas is not seen, even for the alloy 625 separator where it was obvious after 6 mo exposure. This indicates that stray current corrosion may be occurring on all separators of both materials. In fact, stray current corrosion was actually observed on the copper-nickel separators and on the longer alloy 625 separators (in the form of stray current-induced crevice corrosion on the outside of the pipe end under the tubing used to hold the sections together). Linearity still could not be determined for the 1-ft (0.3-m) separators of either material.

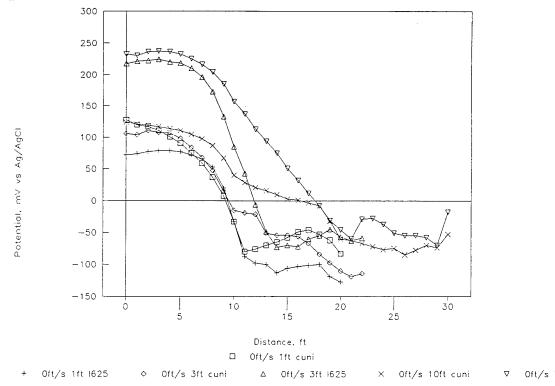
**Figure 18.** Potential profiles of all mockups with separators after 1 yr exposure (less than 1 ft/s [0.3 m/s]).

Figure 18 shows potential readings for all mockups with and without separators tested at less than a 1-ft/s (0.3-m/s) flow after about 1 yr of exposure. The 3- and 10-ft (1- and 3-m) copper-nickel separators show nonlinearity, indicating a possibility of stray current corrosion, and the 3- and 10-ft (1- and 3-m) alloy 625 separators show linear potentials. Stray current corrosion was actually observed on the copper-nickel separators, whereas no corrosion was actually observed on the alloy 625 separators at less than 1 ft/s (0.3 m/s) flow after 1 yr of exposure.

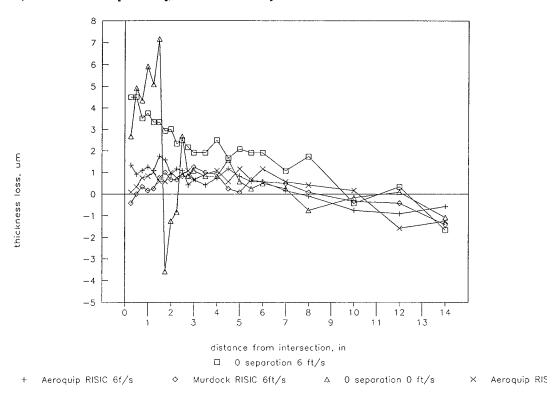
Figure 20. Thickness loss measurements for pipes coupled directly or using RISICs.

The results are shown in Figures 20 through 24. Figure 20 shows the measurements on the pipes directly coupled without the use of a separator or coupled using RISICs. The flange areas could not be measured, so the measurements started just past the weld where the flange was joined to the pipe. Corrosion of directly connected pipe, either with or without flow, was verified by these data. Pipe corrosion where RISICs were used was not obvious, in part because of the large distance from the alloy 625 before the first measurement was made.<sup>f</sup>

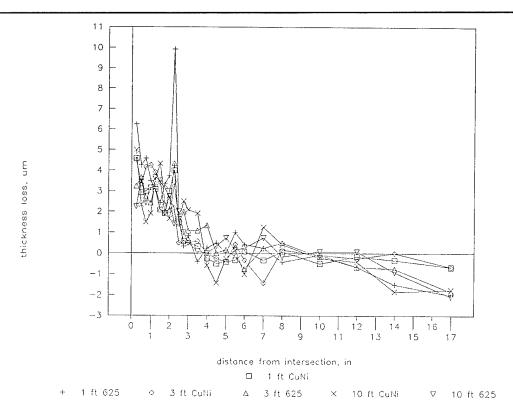
**Figure 21.** Thickness loss measurements for pipes coupled using separators less than 1 ft/s (0.3 m/s).

Figure 21 shows corrosion on the copper-nickel pipe as a function of the length and type of separator material used under low flow conditions. Corrosion near the alloy 625 extending one to two pipe diameters from the end closest to the alloy 625 was confirmed by these data. Although the electrochemical data and visual observations showed an effect of separator length and material, the measurements reported in Figure 21 cannot resolve these effects. Figure 22 shows similar information under flowing conditions.

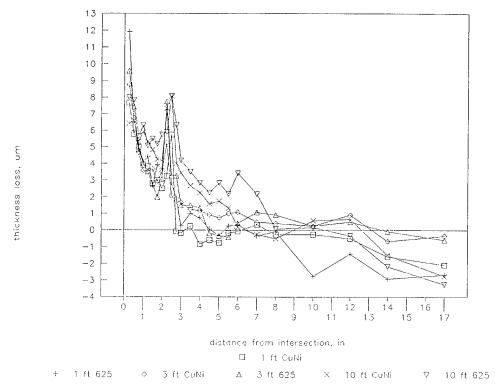
**Figure 22.** Thickness loss measurements for pipes coupled using separators 6 ft/s (2 m/s).

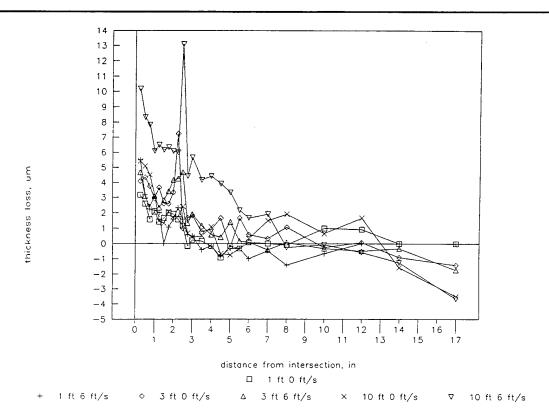
Figure 23. Thickness loss measurements for copper-nickel separator pipes.

Corrosion on the copper-nickel separators is shown in Figure 23. This corrosion was primarily because of stray current corrosion from the potential field set up by the alloy 625 on one side of the separator and the copper-nickel on the other side. The longest separator under flowing conditions shows more corrosion, consistent with the larger driving force for stray current corrosion and with the electrochemical and visual data. Other differences in separator performance were less significant and somewhat obscured by the data scatter, although maximum depths of corrosion appeared related to separator length, consistent with the other observations.

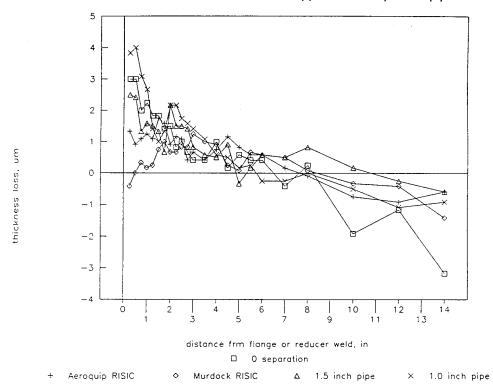
**Figure 24.** Thickness loss measurements for pipes of various diameters compared to pipes coupled directly or using RISICs.

Figure 24 shows the effect of size of the copper-nickel pipe on corrosion. Measurements could not be taken on the copper-nickel reducers closest to the alloy 625, so the first measurements were about 2.5 in. (6.2 cm) from the alloy 625 on these pipes. Maximum depth of corrosion and overall corrosion were greatest on the smallest pipe, as expected. It was difficult to distinguish differences in the amount of corrosion between the medium sized pipe and the largest pipe because of data scatter. It is possible that the greatest differences in behavior occurred within the flanges, the RISICs, and the reducers and were, therefore, not observable for that reason.
